Soils and Foundations

# Geo-environmental issues induced by the 2011 off the Pacific Coast of Tohoku Earthquake and tsunami

The 2011 off the Pacific Coast of Tohoku Earthquake of March 11, 2011, caused devastating geotechnical and geo-environmental issues mainly in the coastal area of the Tohoku and North-Kanto Regions, Japan. As a result of the earthquake and subsequent tsunami, approximately 23,000 Gg (23,000,000 t) of disaster debris was generated, with more than 12 million m<sup>3</sup> of tsunami deposits left in the flooded area. The geotechnical utilization of the soil fraction in the disaster debris and tsunami deposits has presented a huge challenge to geotechnical engineers since (1) the clearance of debris and tsunami deposits is an urgent task which must be completed within a few years and (2) although a large amount of waste-mixed soil can be used in the construction of new embankments and levees to protect the coast from future tsunamis, their geotechnical properties have temporal and spatial variations. This paper summarizes the current status on the generation, clearance, and treatment and utilization of disaster debris and tsunami deposits from geotechnical and g

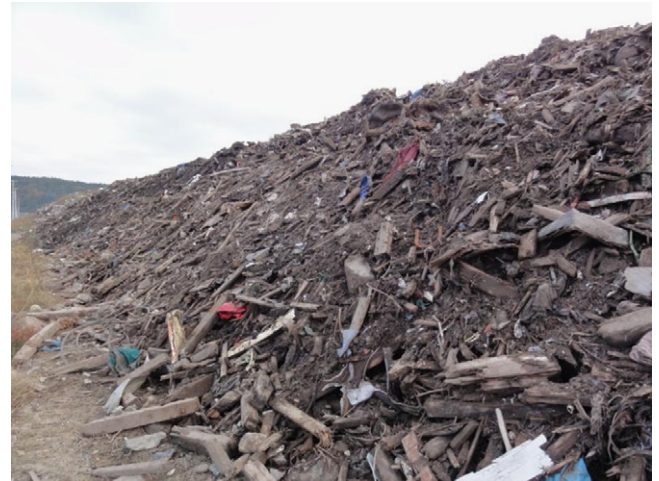
Photo 1. Disaster debris placed in a stockyard in Iwate Prefecture (November 2011).

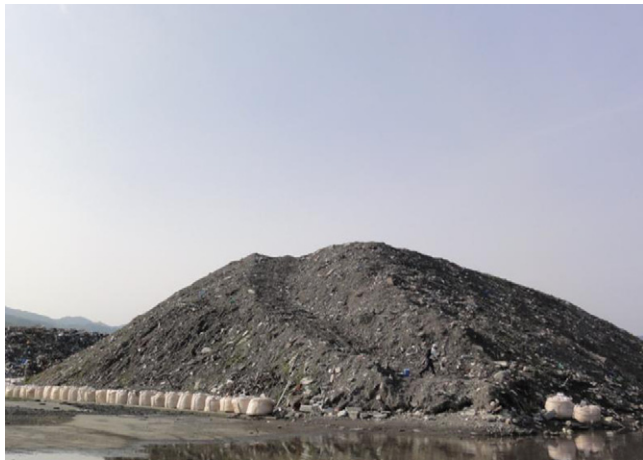
Photo 2. Tsunami deposit placed in a stockyard in Iwate Prefecture (November 2011).

Photo 2 shows the status of the temporary storage of tsunami deposits at a stockyard in Iwate Prefecture. As of March 2012, almost all of the tsunami deposits have been cleared from urban and residential areas and stored in stockyards according to field surveys by the authors. However, most of the deposits in farmlands have not been cleared, as shown in Photo 3 (left). A typical cross section of the tsunami deposit in a flooded farmland is also shown in Photo 3 (right). During a certain period of inundation, finer particles were separated from denser and coarser particles and precipitated slowly upon a coarse layer that had been precipitated earlier than the finer particles. Accordingly, multiple layers with finer and coarser particles were formed upon the original ground. Fig. 4 shows the grain size distribution of finer and coarser layers collected at a farmland in the flooded area (Takai et al., 2012). The results indicated that the lower coarser layer is composed of sand only and has a much higher uniformity than the finer layer.

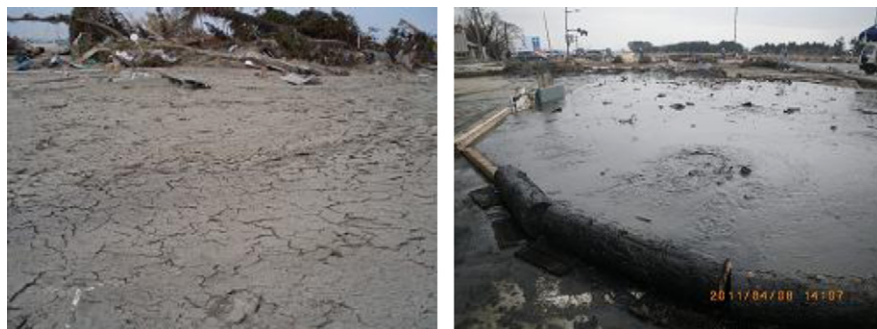
Photo 4. Overviews of the sampling sites (Left: Site S, Right Site H) (Katsumi et al., 2011).

Katsumi et al. (2011) investigated some physical properties of 17 tsunami deposit samples collected at five tsunami-affected sites (Sites I, S, N, Iw and W) in early April 2011 in Miyagi Prefecture. The water content of the tsunami deposits varied significantly, as shown in Photo 4. At some sites, such as Site H, the inundation had yet to completely subside due to poor drainage, which was caused by how the land was used or existing structures. Fig. 5 shows the grain size distribution of each sample collected (Katsumi et al., 2011), and Fig. 6 shows the fine fraction content ( $< 75 \mu\text{m}$  in diameter) compared with the JGS classification for geo-materials according to JGS-0051 (JGS, 2009).

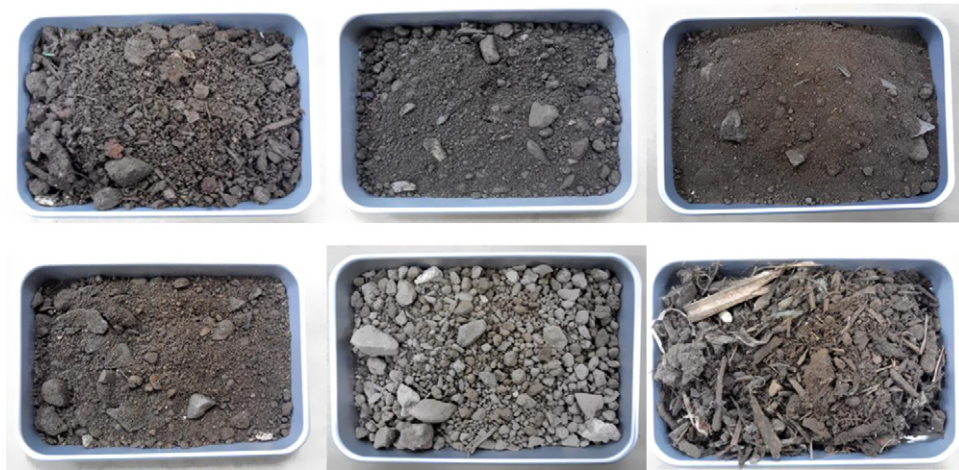
Photo 5. Overviews of the waste-mixed soil samples from several sites.

Katsumi et al. (2012) investigated the Proctor compaction properties of waste-mixed soil samples collected at temporary stockyards for mixed disaster waste and tsunami deposits, and at a treatment facility of disaster debris. The focus was placed on the influence of the content of the combustible fraction on compaction properties. The results clearly indicated that the existence of combustible matter like wood and textiles influenced compactibility, and that a higher content of combustible fraction resulted in a lower maximum dry density. The need for efficient separation and treatment processes to extract waste matters selectively from waste-mixed soil and tsunami deposits is, therefore, quite clear. Figs. 8 and 9 show the typical flow for the treatment of mixed debris, according to the master plan for the treatment of disaster waste (MOE, 2011a), and tsunami deposits, according to the guideline from MOE (2011b). The fundamental concept of this plan and guideline is that as much reusable material, such as concrete debris, wood waste, and electric appliances, should be extracted from the mixed debris and treated properly, and the amount of landfill and associated cost should be minimized. In a practical treatment process, large fractions, such as concrete, timber, and metal, are first separated manually or mechanically for reusing/recycling. Afterwards, through crushing and sieving processes, waste matter is selectively removed from mixed waste, and then incinerated and/or disposed of in waste landfills, as shown in Fig. 8. However, the fraction finer than the minimum opening size of the
